Baustatus BT-Grundsicherung Herder

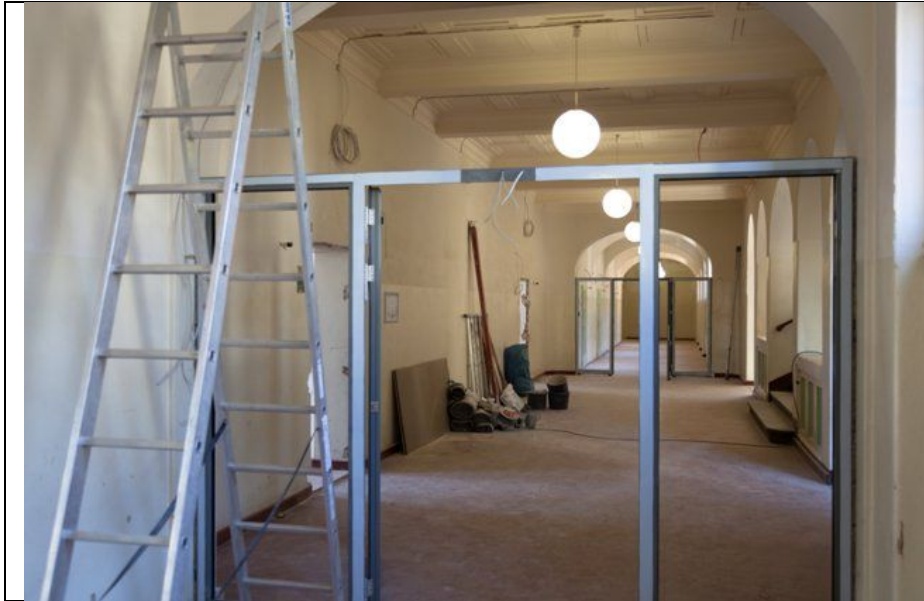
Flurbereich Brandschutztüren

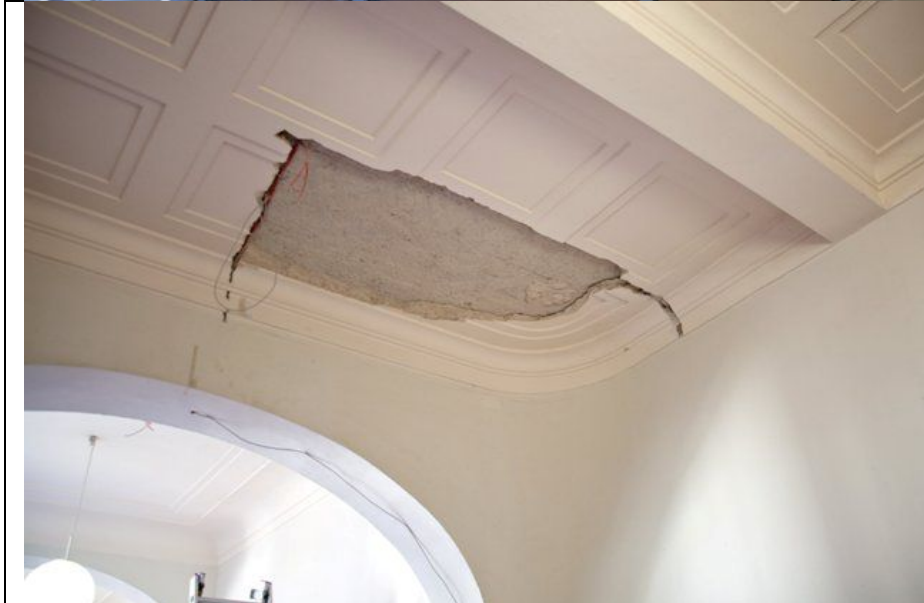
Kann passieren...

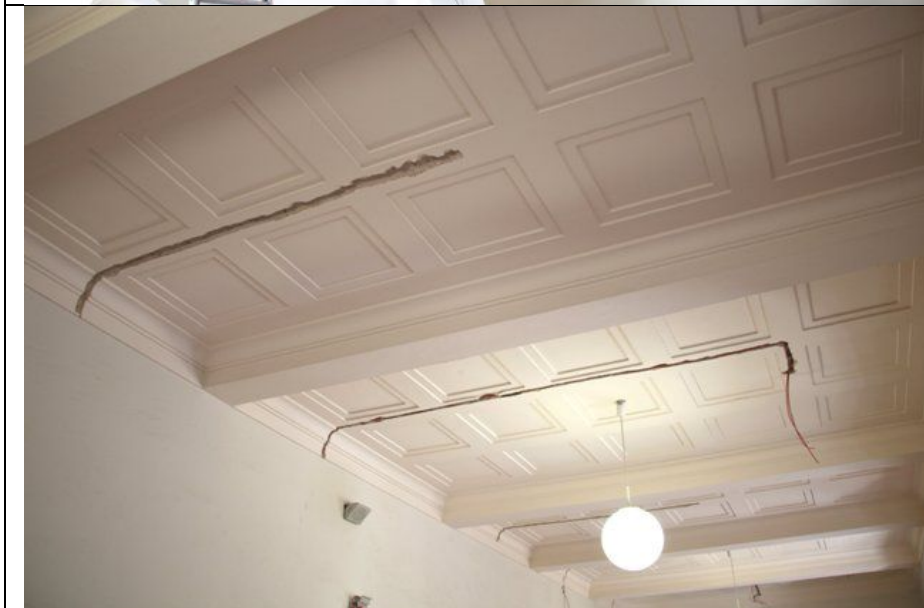
Kabelverlegung

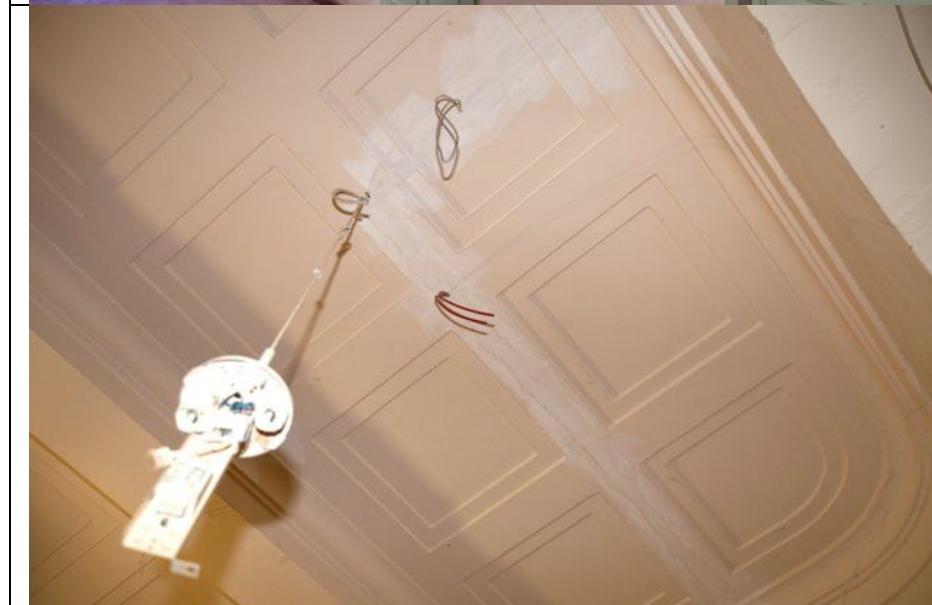
Deckenbereich nach Kabelzug

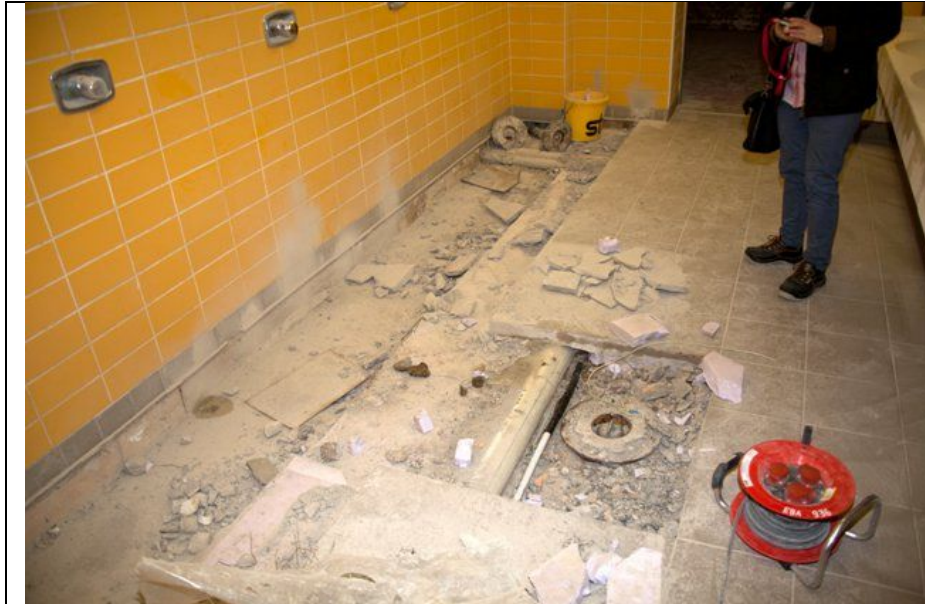
Mängelbeseitigung,
entdeckt bei
Befundaufnahme

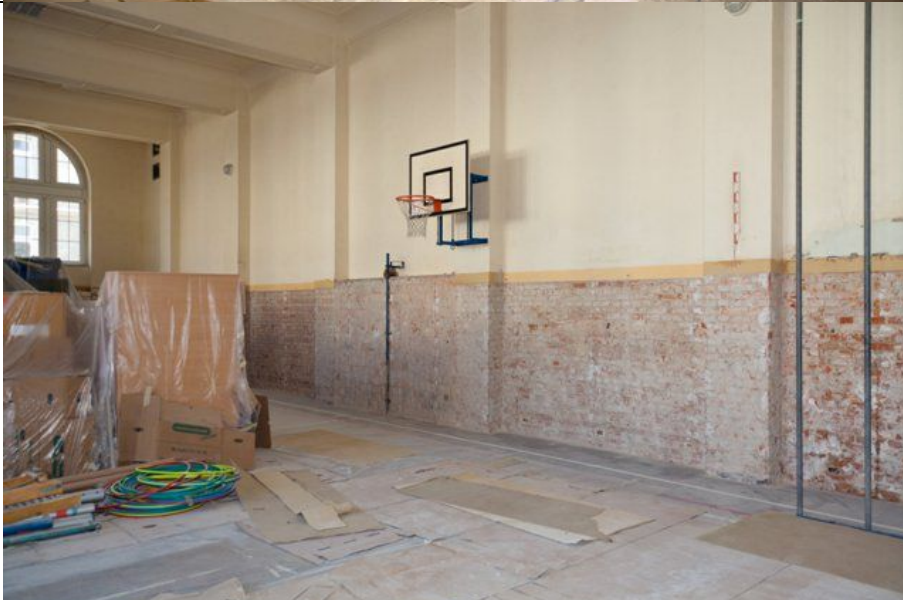
Sanierung Turnhalle

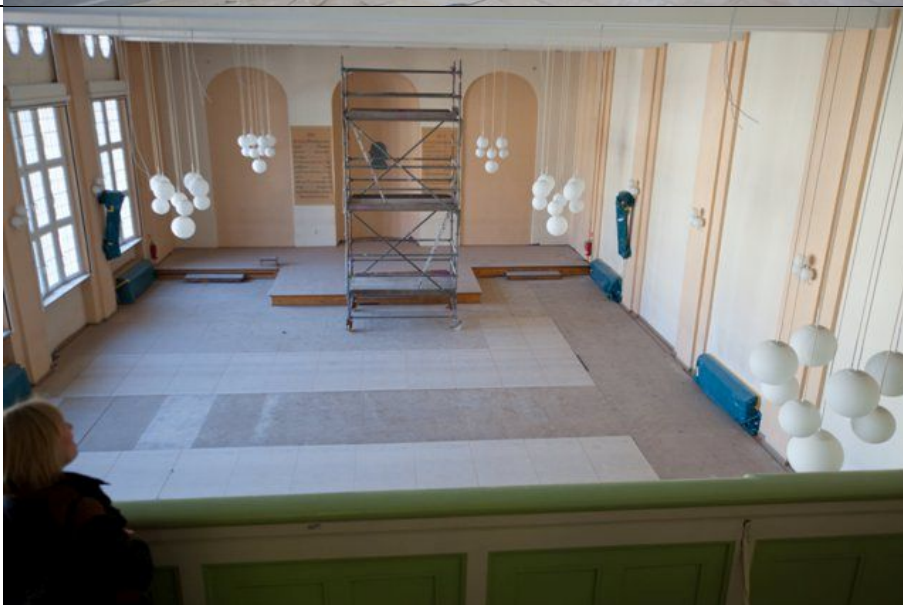
Aula - fast unberührt
(nur Arbeiten im
Deckenbereich)
